**Appendix C**  
**Structural Engineer's Report**

**First Unitarian Society of Plainfield**  
**Plainfield, New Jersey**  
**RSA #12454**

**Summary of Observations and Recommendations Regarding the Structural Conditions of the**  
**First Unitarian Society of Plainfield**

**Report Date: February 24, 2008**  
**Addendum: February 11, 2008**

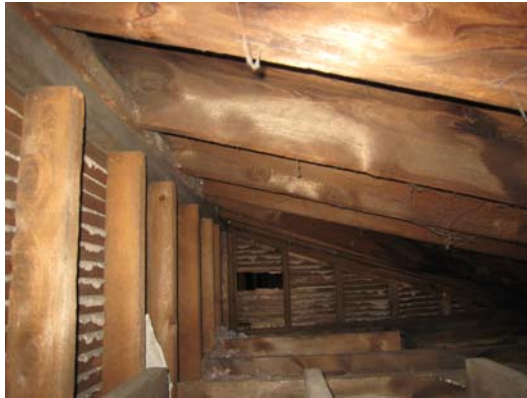
The roof framing could not be directly observed due to inaccessibility during the initial visit. The small portion of the roof framing that was observed did have some minimal water staining (see Photograph 2), but appeared to be dry and did not show any signs of significant deterioration or excessive stress. Access was provided for additional observation of the roof framing during the subsequent probe investigation, and was observed to be in good condition. Refer to the Probe Summary attached for additional information.

Photograph 2: View of accessible Church roof framing above the north side aisle. Framing was observed to be in good condition with only minor staining of wood members. Access was limited to above the office only.

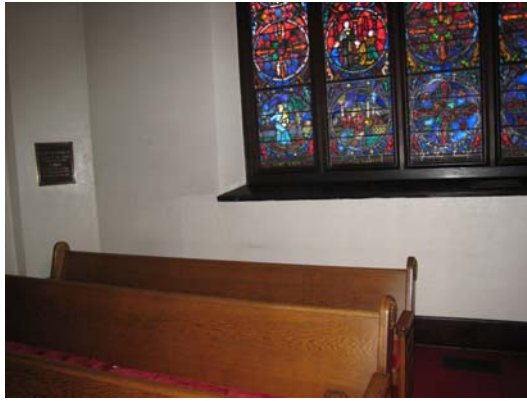
- Previous repairs and newer cracks at the bottom corners of the large Robinson Window (Window #W101). Sees 3 through 6. Removal of plaster finishes during the probe investigation revealed that the cracks did not propagate into the masonry.
- Water damage at the ceiling of the southeast corner of the sanctuary. This may indicate significant deterioration of structural members in the ceiling cavity at this location due to

Photograph 4: Interior view of large stained glass window (W101). Diagonal cracks were observed in the architectural finishes at each lower corner.

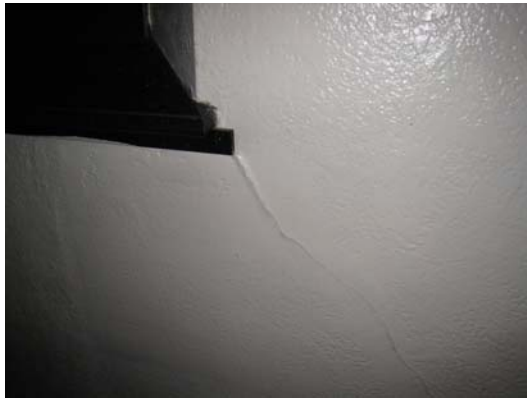
Photograph 5: Closeup view of cracks in plaster at window corner.

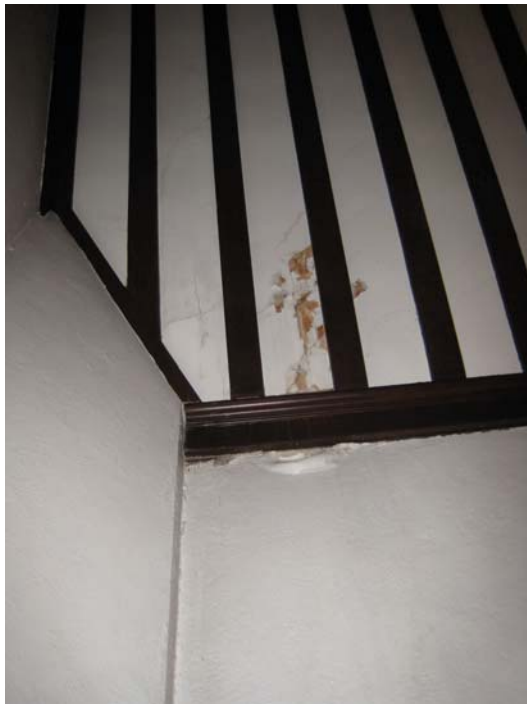
Photograph 6: Southeast corner of sanctuary. Cracks and water damage visible.

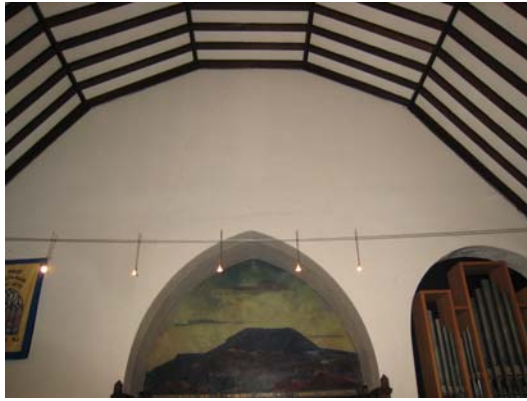
- Cracks above the altar area at the west end of the sanctuary (see Photograph 7). It is not believed that these cracks are structural related.

Photograph 7: View of west end of sanctuary space. Diagonal cracks were observed at plaster finishes.

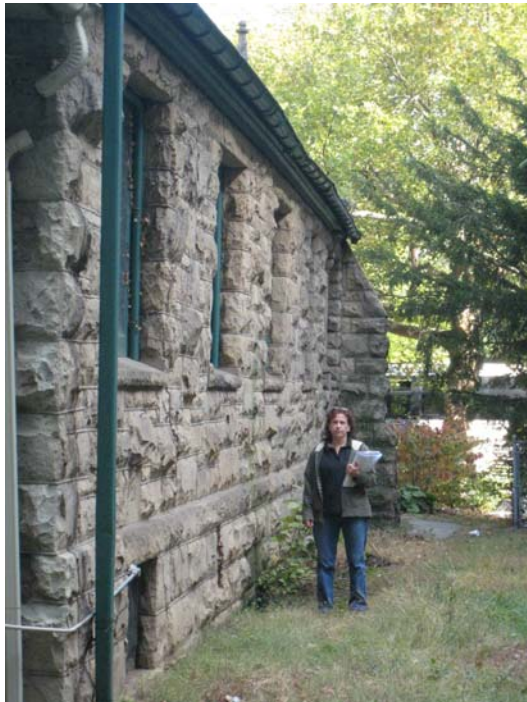
The general condition of the exterior bearing masonry walls above the foundation level is fair to good. The south wall was observed to have significant outward displacement at the top of the wall where it meets the roof. Photograph 8 illustrates this condition. It is believed that the walls are currently stable, however further investigation as described below is required to determine if the displacement is active.

There have been no reports of recent damage on the interior at this area and the finishes do not show any signs of deterioration or cracking indicating that it is likely that the displacement stabilized many years ago and is not active, or the movement has been very slight over a very long period of time.

Photograph 8: View of Church South façade showing the observed deflection at the top of the wall.

It is recommended by RSA that the wall be monitored for a length of time required to determine if there is any active movement or if reinforcement is necessary. This can be done by regularly measuring the amount of displacement, such as monthly or quarterly. The condition of the sill plate at the top of the masonry wall was not accessible at the time of observation.

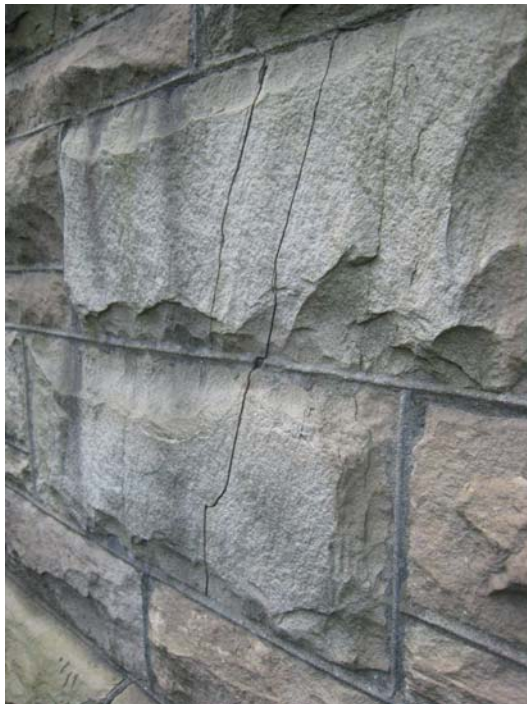
Photograph 11: Limited cracks observed through masonry units.

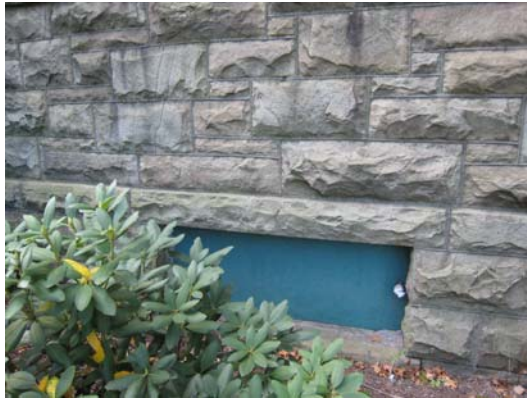
Photograph 12: Cracks observed at the basement window lintel. (W021)

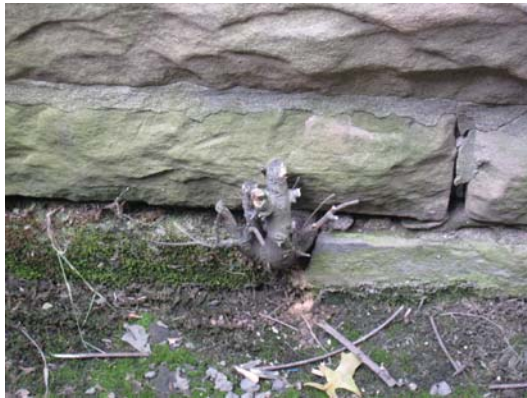
Plant growth was observed on and within the south masonry wall (see Photograph 13). These plants may lead to excessive stress and structural damage of the masonry and should be immediately removed. Water staining and biological growth, which lead to accelerated deterioration of the masonry was also noted along this wall at broken or missing rainwater leader locations (see Photograph 14). Excessive deterioration of structural masonry leads to the destabilization of the structural wall. See HBA report for recommendations for rainwater maintenance and biological growth removal.

Photograph 13: Plants were observed growing within the plane of the exterior masonry wall of the Church.

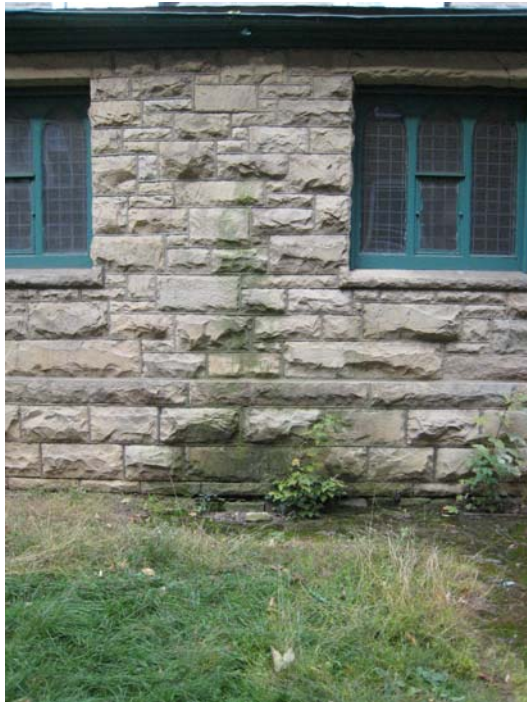
Photograph 14: Water staining observed on the south façade of the Church. The missing drain allows rainwater to keep the masonry in an almost constant state of saturation. This leads to the deterioration of the stone and mortar and could thus compromise the structural integrity of the wall.

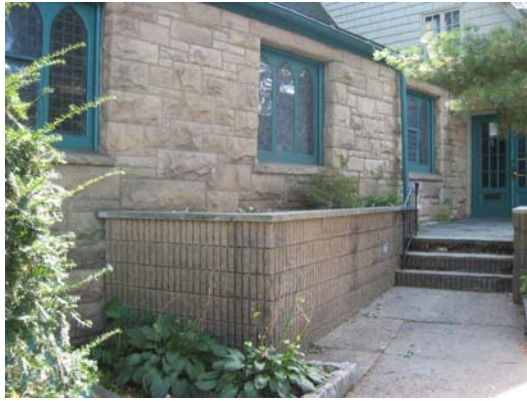
A primary source of problematic structural conditions of the Church is found at the porches and terraces of each entrance. The raised planter of the Powell Terrace, (Photograph 15) installed in 1977 along the north wall, appears to be causing significant deterioration to the masonry foundation wall at this location (See Basement and Foundation). It is likely that adequate waterproofing and drainage was not provided at the terrace at the time of construction (See Probe Summary for additional findings and recommendations). It is recommended by RSA that this planter be removed and the foundation wall of the church be repaired.

Photograph 15: View of Planter at the Powell Terrace on the north façade of the Church.

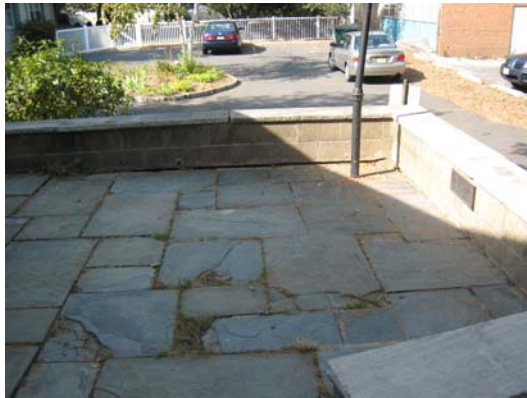
Settlement, lack of adequate drainage/waterproofing and general wear has resulted in the deterioration of the terrace. Efflorescence was noted on the exterior below the weep hole levels and plant growth was visible between and below the terrace stones. Structural repairs are necessary to prevent further deterioration. (See Photographs 16-18)

Photograph 16: Displacement observed at the Powell Terrace. Other forms of deterioration observed at the terrace include displacement, through stone and mortar joint cracking, efflorescence staining and signs of settlement.

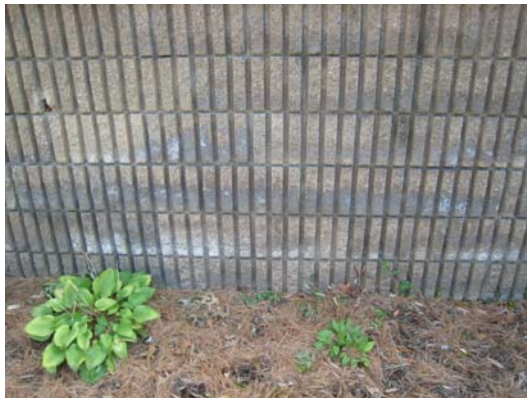
Photograph 17: Efflorescence at the Powell Terrace.

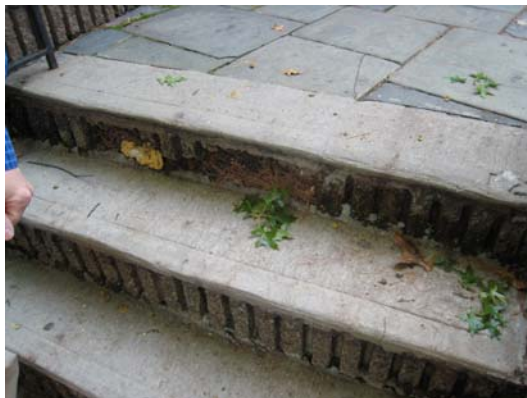
Photograph 18: Un-maintained stair at Powell Terrace.

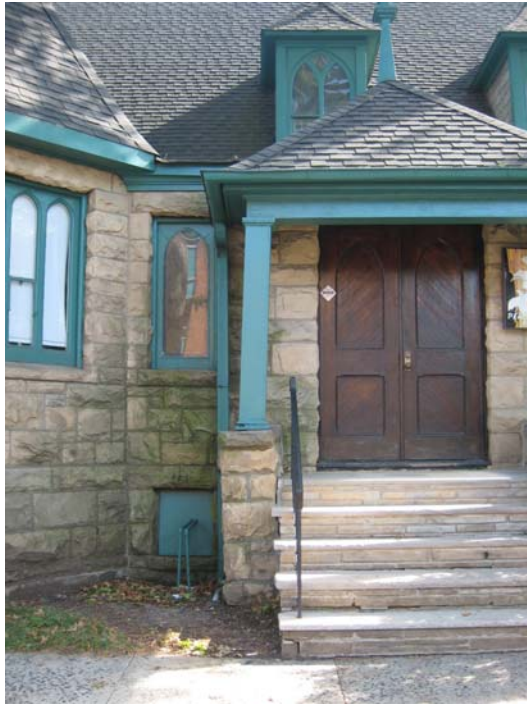
The Church entrance on the north façade has a raised porch with a small hipped roof (see Photograph 19). Two wood posts on masonry knee walls that support the roof show significant signs of movement. The movement was observed to be greater than two inches in some locations (see Photographs 19, 20). Cracking and previous repairs of the mortar joints along the knee walls indicate that this is an ongoing problem. The displacement is likely caused by erosion of the soil (rain water control) and differential settlement due to an inadequate foundation for the steps and

Photograph 19: View of conditions at north façade porch entrance of the Church. Settlement and/or movement has lead to significant displacement of porch kneewall.

porch. It is recommended by RSA that the porch roof be temporarily shored and the knee walls and steps be completely rebuilt on a new foundation.

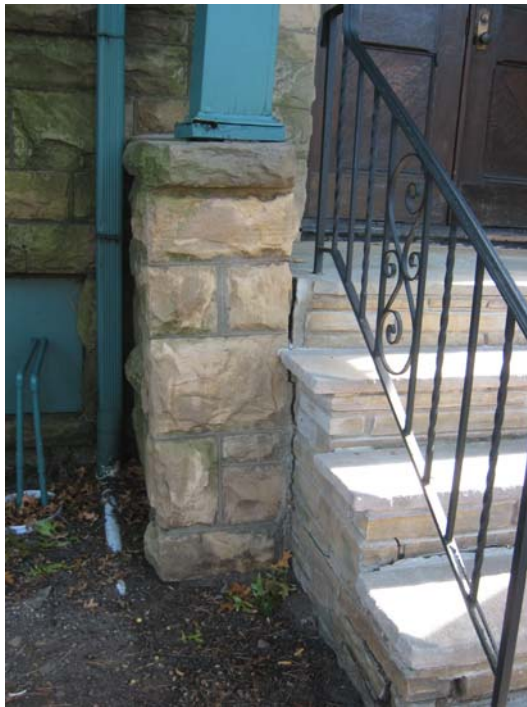
Photograph 20: Crack at stair showing displacement of masonry.

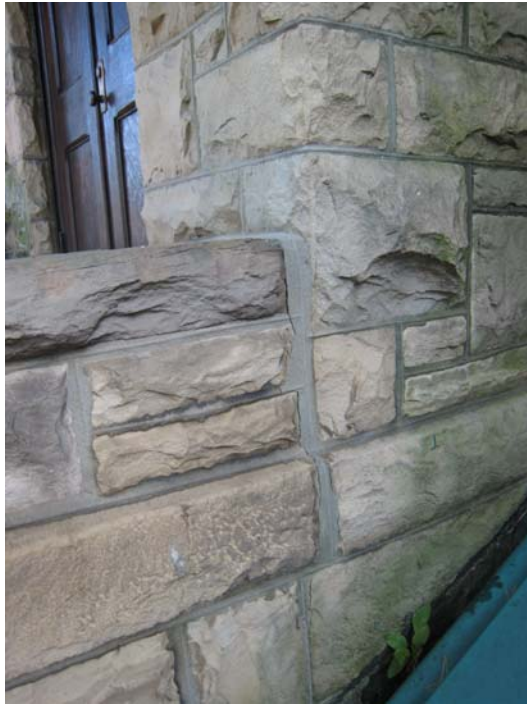
Similar cracking and signs of movement are found at the steps of the entrance at the southeast corner of the church (see Photograph 21). There is a minimal amount of deterioration at the raised portion of the porch, but the steps are in poor condition. The stone appears to be different than the stone found elsewhere in the Church indicating that they may have been replaced and/or previously repaired. RSA recommends that the stairs and knee walls be rebuilt. Broken and cracked steps are a trip hazard and therefore should be repaired in a timely fashion.

Photograph 21: Excessively wide mortar joint indicates a previous repair was done at point of displacement. New cracking indicates the movement continues.

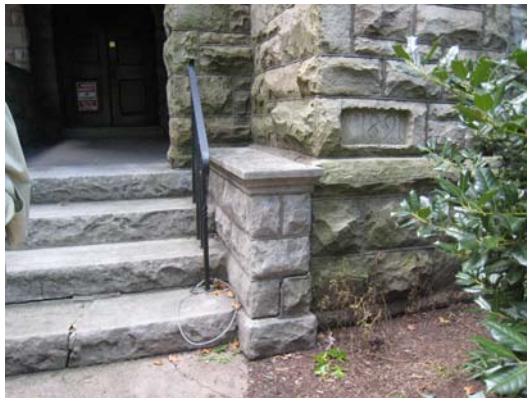
Photograph 22: Cracking and displacement observed at the southeast corner of the Church.

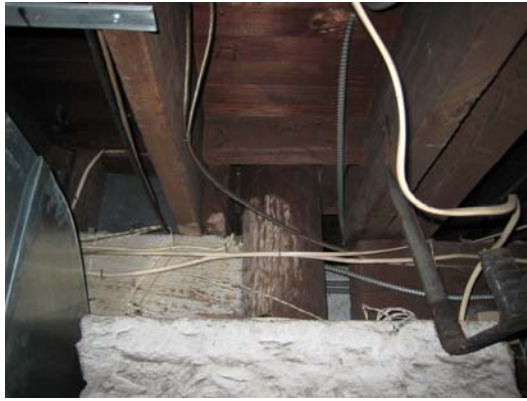
Photograph 24: Typical wood post support at masonry pier observed in good condition.

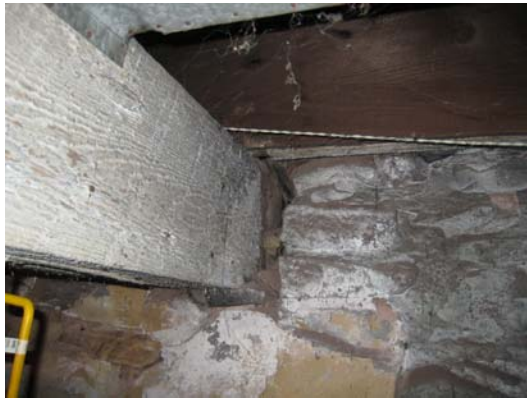
Photograph 25: Loose material/possible rot observed at beam pocket.

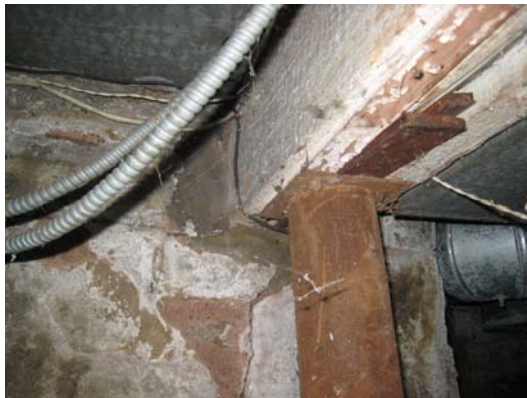
Photograph 26: Previous repair/stabilization at basement north wall. Steel column has been added to support wood member.

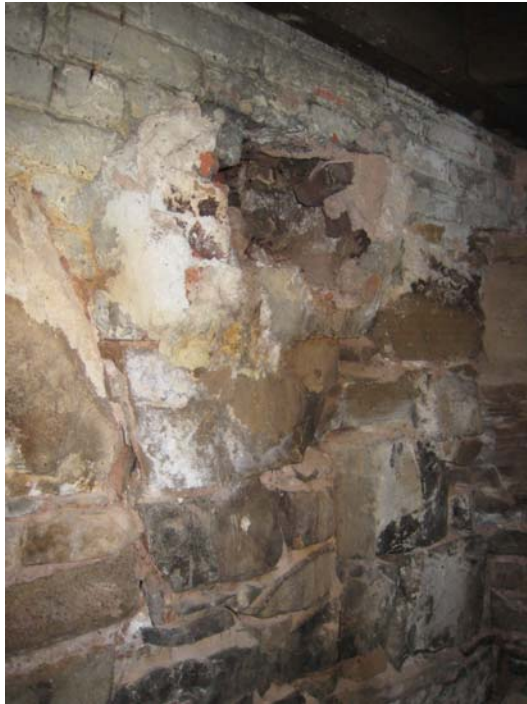
Photograph 27: Typical basement wall conditions observed along the east wall include cracked, open mortar joints and efflorescence. Repointing is necessary to prevent further deterioration of wall.

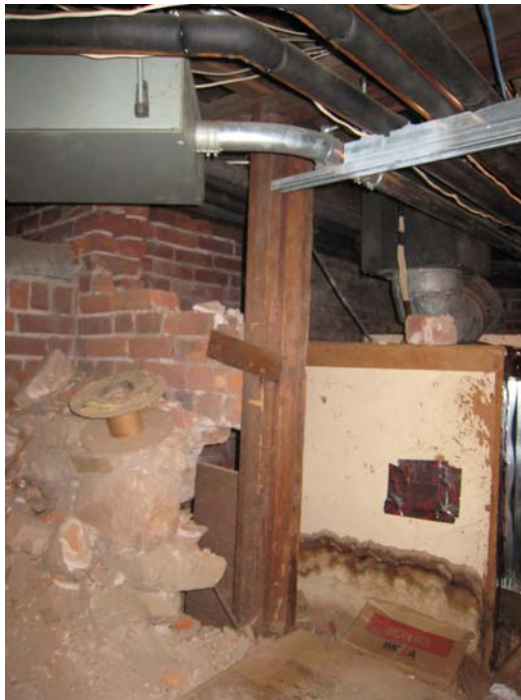
At the west foundation wall, crumbling masonry and wood posts support the opening into the crawl space of Parish Hall (see Photograph 28). It is recommended that this opening be shored and a stainless steel lintel be installed to support the opening, or the opening could be filled in with new masonry. Two larger masonry piers were observed along the west foundation wall but they do not appear to be supporting anything at this time (see Photograph 29). In addition, the last bay of framing along this wall has double floor joists suggesting that a heavier load was being supported above at one point in time. It is possible that the piers were used to support elements at the altar area, such as the original organ, that have since been removed or may have been part of a previous alteration.

Photograph 28: View of inadequate shoring/opening support at connection between Church and Parish Hall crawl space.

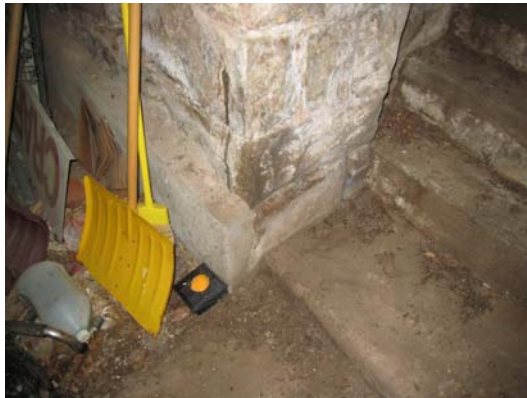
Photograph 30: Concrete underpinning observed at north basement wall.

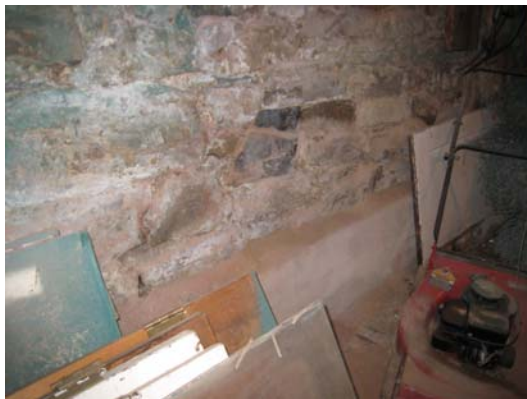
Photograph 31: Brick/mortar dust has accumulated at the concrete ledge and on the floor along the north foundation wall.

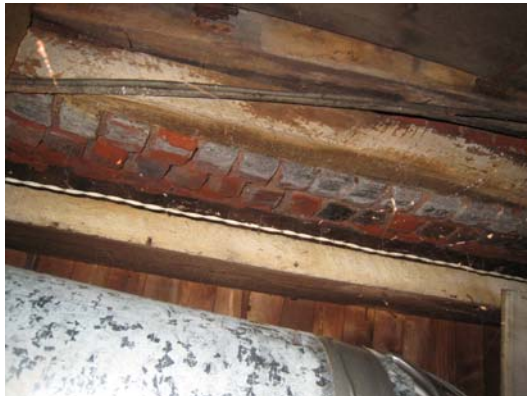
Photographs 30 and 31 show concrete underpinning along the north foundation. Where this wall corresponds with the Powell Terrace on the exterior, significant mortar loss and deterioration of brickwork was observed (see Photograph 32). This much loss in mortar has a significant effect on the structural stability of the wall and requires extensive repair. The full extent of the damage could not be observed as much of the deterioration occurs above the basement ceiling level. See Probe summary for recommendations for further investigation.

While there is no reason to believe that there is an immediate danger or safety concern associated with the advanced level of deterioration observed along the north foundation wall, this is the most crucial structural element in need of repair and it is highly recommended by RSA that additional investigation and subsequent repairs be implemented as soon as possible.

Photograph 32: Looking up at poor brick condition at north foundation wall of the Church along the inside face of the Powell Terrace. Significantly deteriorated brick/mortar joints require structural repair.

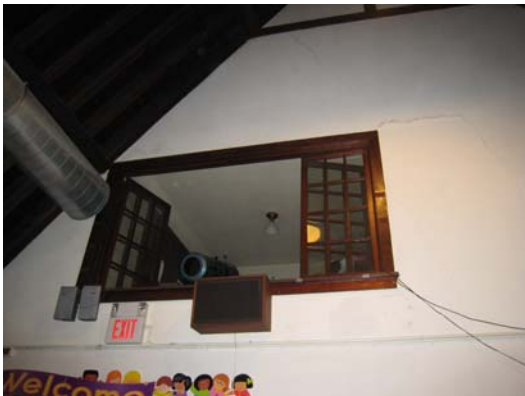
Photograph 35: Cracking observed in plaster finishes on east interior wall at the Parish Hall main room.

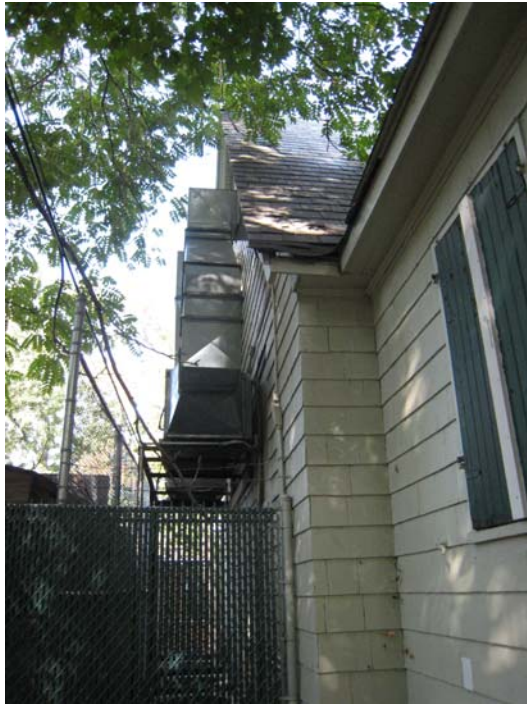
Photograph 36: Roof at Parish Hall at west end not adequately detailed.

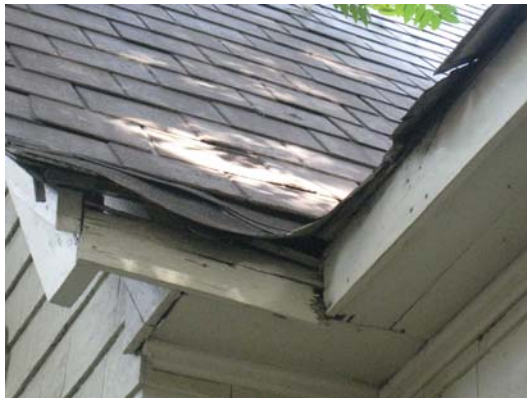
Photograph 37: Close up view of roof detailing. Repair required. (See HBA report).

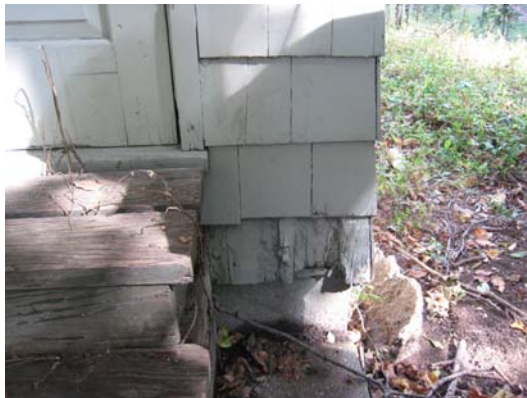
Photograph 39: Potential rot condition at sill plate

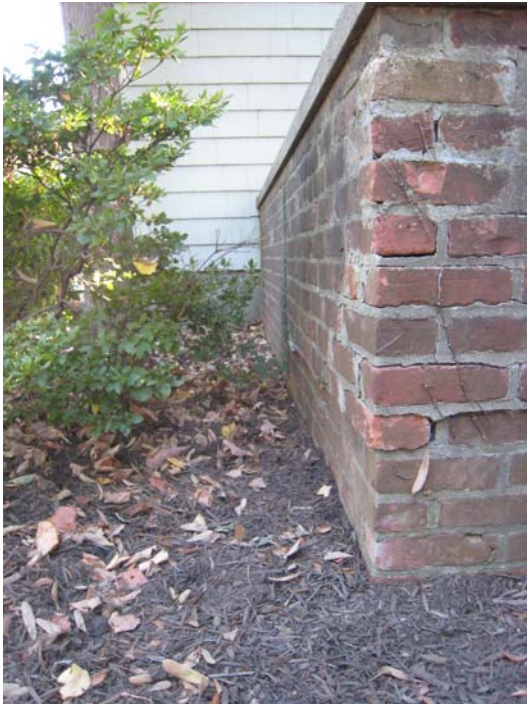
The terrace to the north of the Stevens Room is exhibiting signs of disrepair. There is evidence of differential settlement and movement of the masonry and large cracks have developed in the

mortar joints (see Photographs 41, 42). Jacking of the masonry may be taking place due to years of freeze thaw cycles and the use of very hard mortar. Similar jacking can also be seen at the southeast corner basement entry steps (see Photographs 43). It is recommended that the deteriorated areas of the terrace be rebuilt.

Photograph 41: Open joints and movement observed at terrace north of Stevens Room.

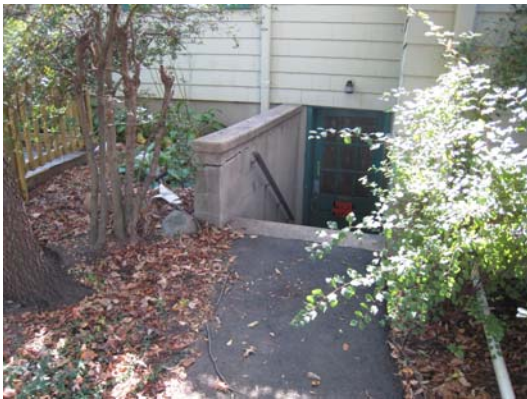
Photograph 43: Cracking observed at retaining wall.

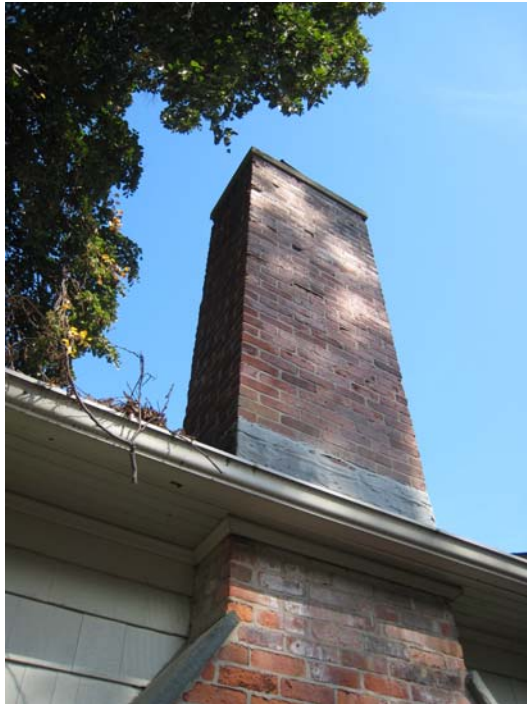
The masonry chimney located on the west façade has a few notable cracks which may require further investigation. The surface of many of the bricks has spalled and loose material is present (see Photograph 43). This may be caused by poor brick quality or poor choice in mortar when it was last repointed. (See HBA report).

Photograph 44: Condition of chimney at Stevens Wing west façade.

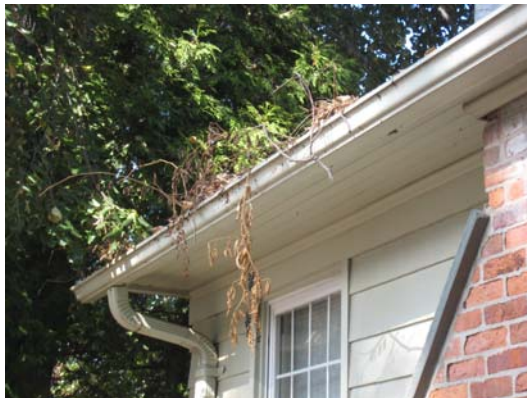
Photograph 45: Gutters full of debris.

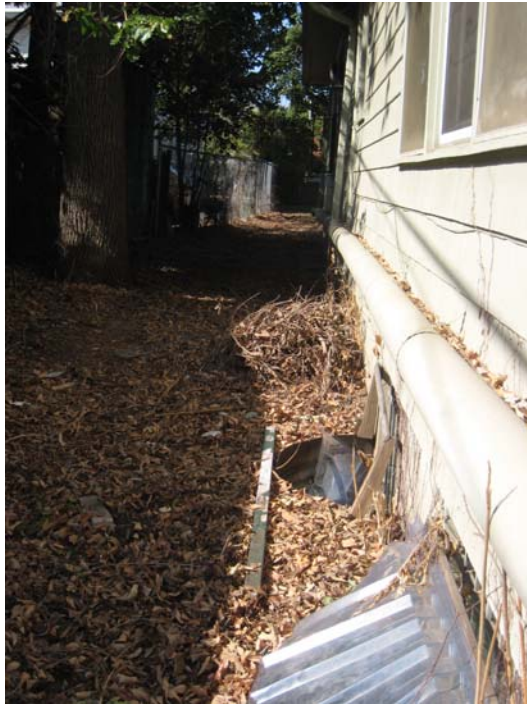
Photograph 46: Debris and plant overgrowth lead to accelerated deterioration of structural foundations at west side of Stevens Wing.

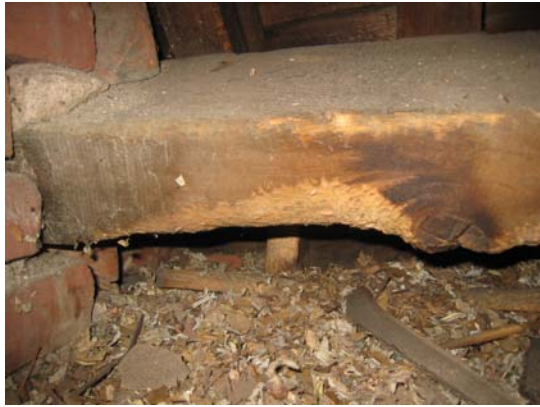
Photograph P4.2: Evidence of animal damage at roof framing at southeast corner.

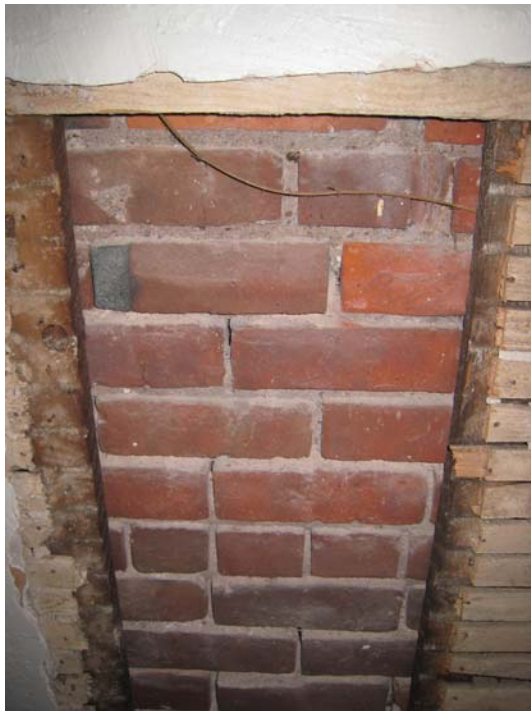
Photograph P5.0: Condition of inside face of east masonry wall. Material coming across the masonry at the top of the opening appears to be wire or a sliver of wood lath. It is not a crack.

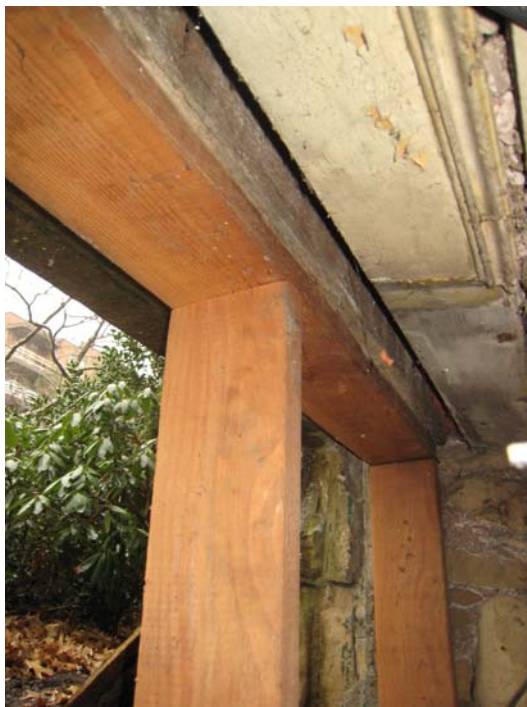
Photograph P6.1: Shoring of basement lintel is providing some structural support for the very shallow brick arch.

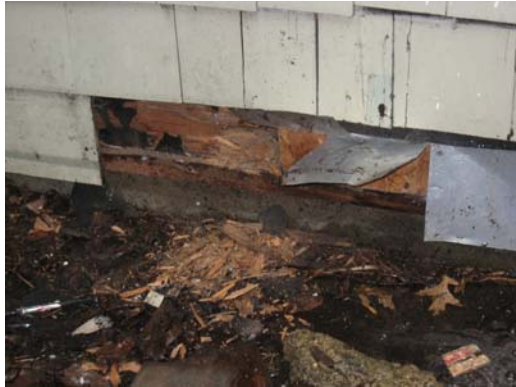
Photograph P7.1: Additional location along the South wall of the Parish Hall addition. The condition of the sill is very poor below the window.
